LEVEL 2

Your survey report

6 Allensbank Road, Cardiff, CF14 3RB

06-01-2025

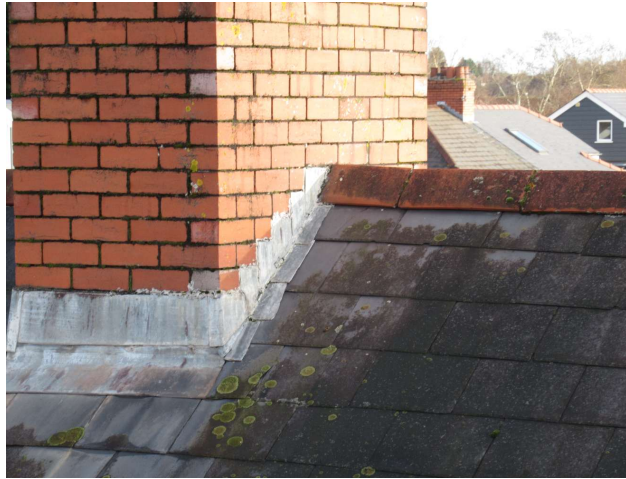
Note repair to lead.

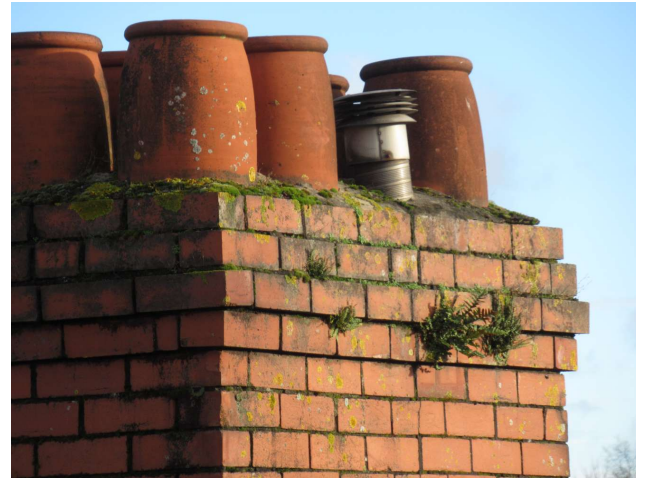
Front/side.

- Terminal fittings should be fitted to the redundant pots which will allow ventilation but prevent rainwater penetration.
- The cement bedding holding in place the pots (called flaunching) is cracked and damaged.
- The mortar between the bricks (called pointing) is cracked, worn and missing.
- Part of the brickwork has displaced/is uneven. There is also some hairline cracking to the surface of the bricks which will deteriorate over time.
- Vegetation growth should be removed on any damage found made good. Old vegetation has also caused damage to the brickwork.
- Part of the lead flashing has dropped out of place. Some repairs have been carried out with silicon which will have a limited lifespan. There is general wear to the flashing.

- Part of the brickwork and flaunching may be loose. This could fall, causing damage or injury. (See Section I-Risks).

This safety issue should be addressed now; other remedial works should be carried out soon and the chimney maintained the normal way thereafter.

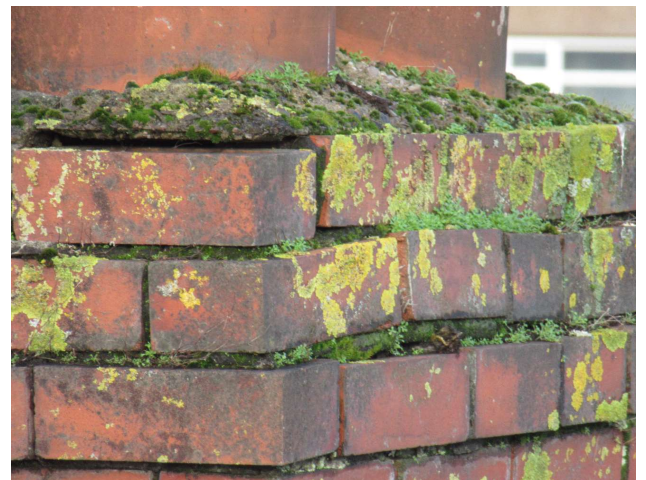
Loose material, uneven brickwork.

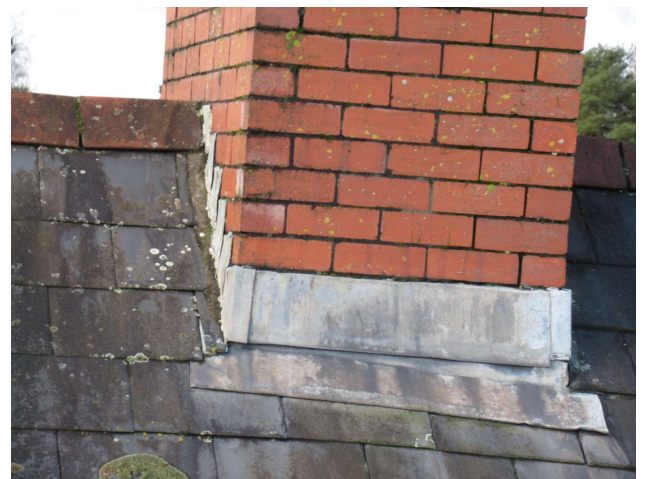
Dropped lead.

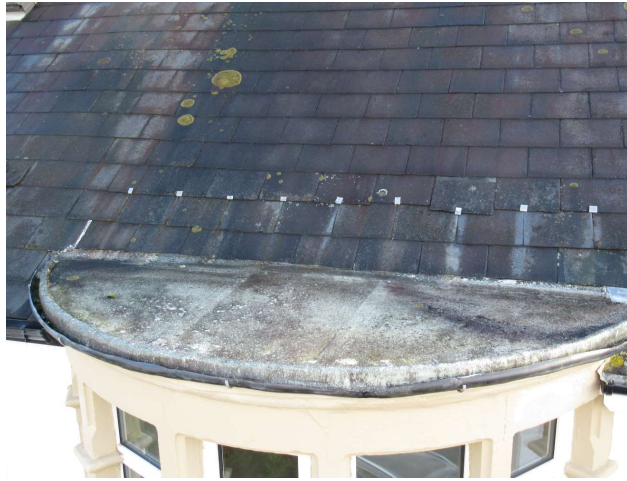
Bay, also note tinges.

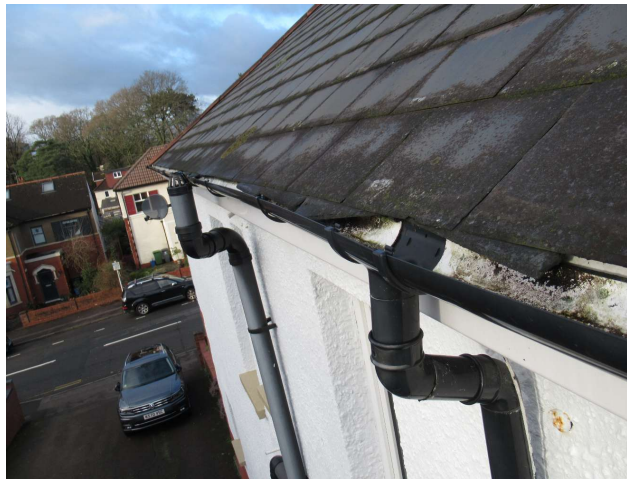
- These roof coverings are original to the house, and there is damage, wear and deterioration.
- Some slates have slipped and are missing. Several are held in place with metal clips called tingles.
- Some slates have been replaced with imitation slate tiles; these are deteriorating.
- The cement mortar holding in place the topmost ridge and hip tiles is worn and missing.
- There is some water penetration around the valley gutter area.
- The joint between the main roof and bay is poorly finished

Slipped slates.

These roof coverings are reaching the end of their serviceable life, and the lack of roofing felt will make the roof space vulnerable to water penetration from driving rain and snow. You should budget to replace these roof coverings completely. A roofing contractor may advise you that it is more cost-effective to replace them now rather than undertake costly remedial works.

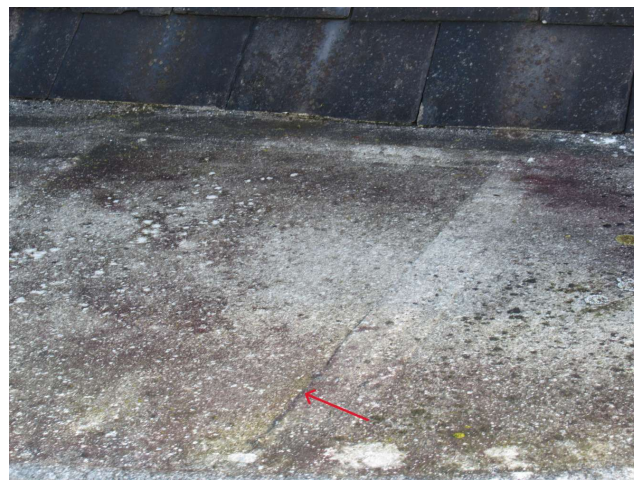
- A layer of dirt restrict my inspection however there appears to be some hairline cracking to the surface. In my experience, the protective layer over the fibreglass will also be deteriorating.

Hairline cracking.

Assessment and remedial works should be carried out soon. This type of roof covering can have a limited life expectancy and fail suddenly, without warning.

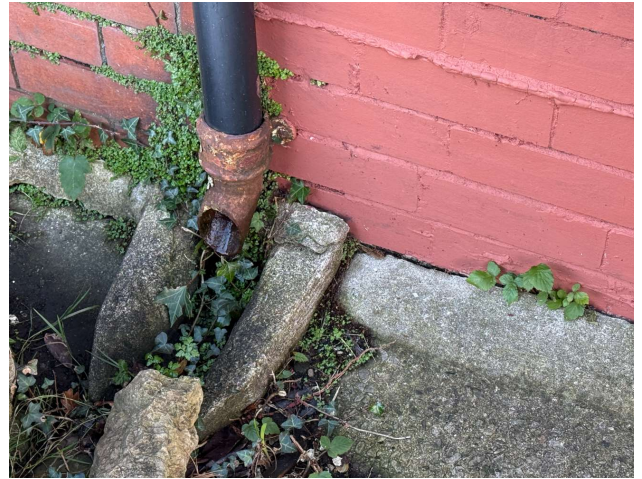
The old metal fitting (noted at the front) is rusting and deteriorating and you should plan to replace it.

Metal fitting.

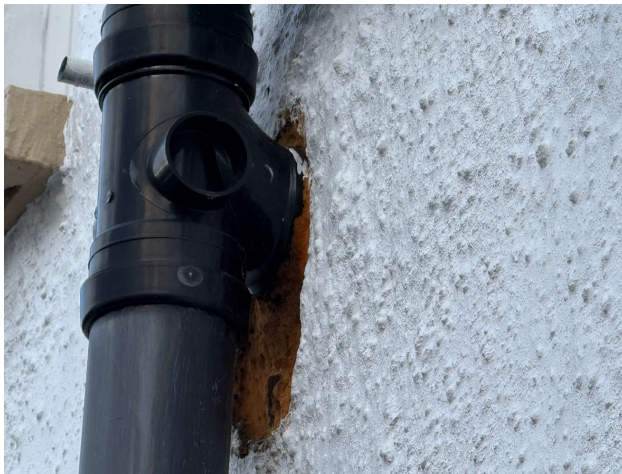
Making good needed.

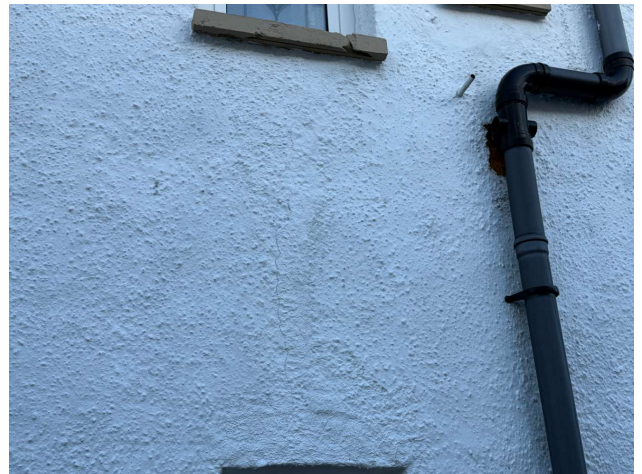
Cracked render.

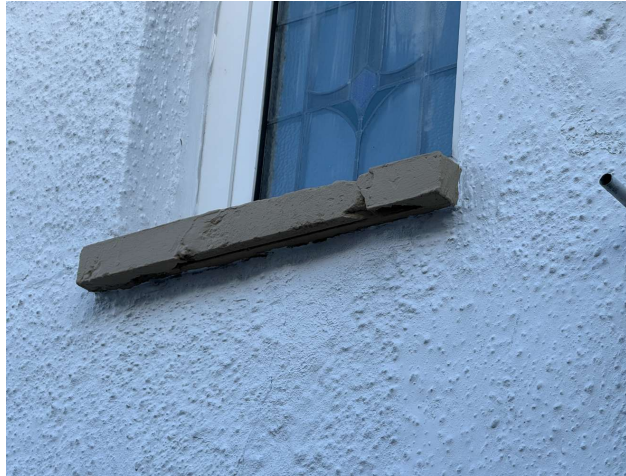
Damaged sill.

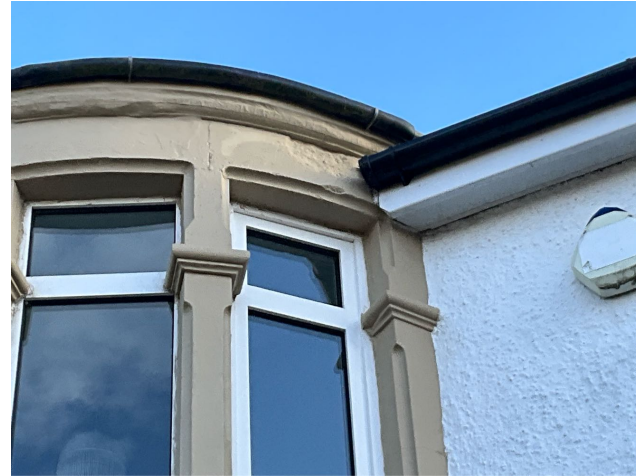
- Part of the stonework is in poor condition and loose. This could fall, causing damage or injury.

Damaged stonework.

You should arrange for this safety issue to be addressed now. An appropriately qualified person should also repair the stonework.

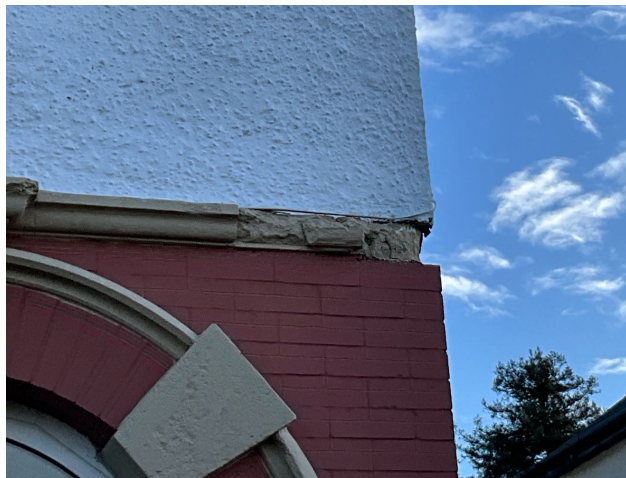
Loose material.

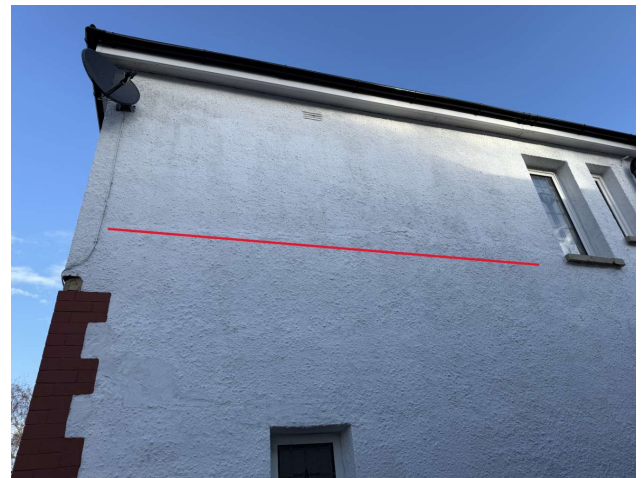
- There is horizontal cracking to the walls which is indicative of cavity wall tie failure.

The inside and outside faces of a cavity wall are connected with metal straps (called wall ties). These wall ties can rust and when this happens, the metal expands and damages the brickwork. In the worst case, this can lead to a partial collapse of the wall. You should ask an appropriately qualified person to inspect the walls and carry out identified repairs. To assess the wall ties properly, the surface of the wall will have to be disturbed and you should discuss this with the current owner. (See Section I – Risks).

Horizontal cracking.

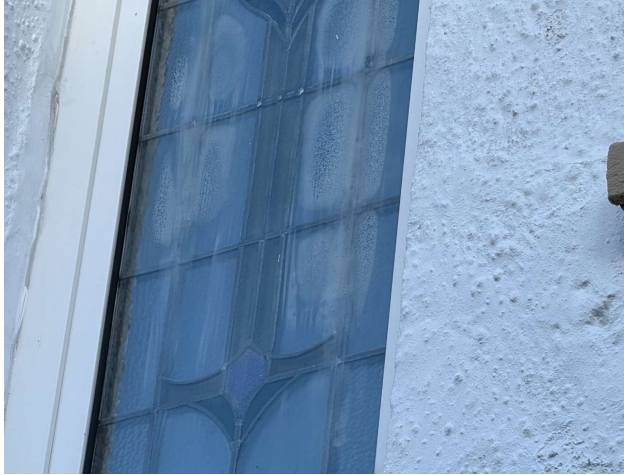
- Some double glazed units have failed, and the space between the glass panes has misted over.

Over time, double glazing units can fail allowing misting or condensation to form on the inside faces of the glass. This is not a serious defect, but it is unsightly and can reduce thermal efficiency of the double glazing. Where some double glazed panels have failed, the remainder could suffer similar problems and you should plan to replace others in future.

Failed glazing.

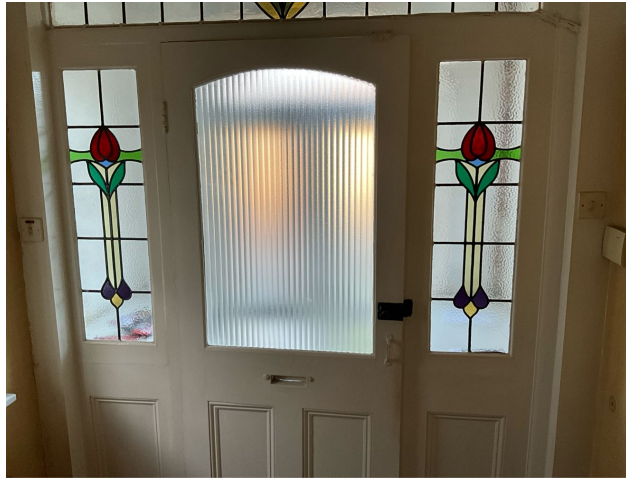
- There is no clear indication that some of the doors contain safety glass. This is a hazard and could result in injury. (See Section I - Risks).

Not safety glass.

You should arrange for this safety issue to be addressed now. Given the overall condition of the windows, they should all be assessed by an appropriate qualified person and remedial works carried out as necessary, soon.

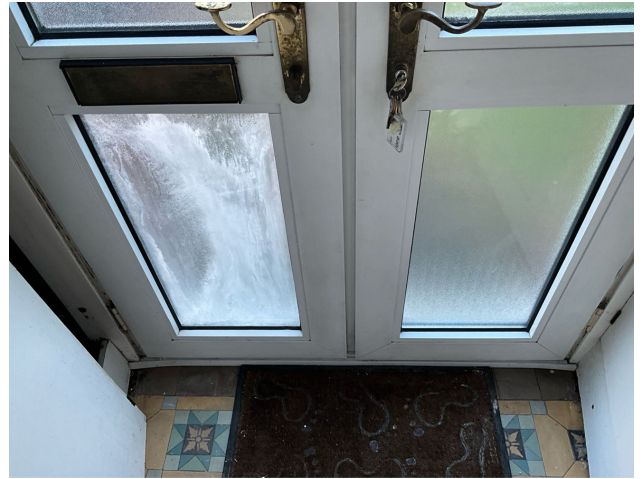
Failed glazing, safety glass?

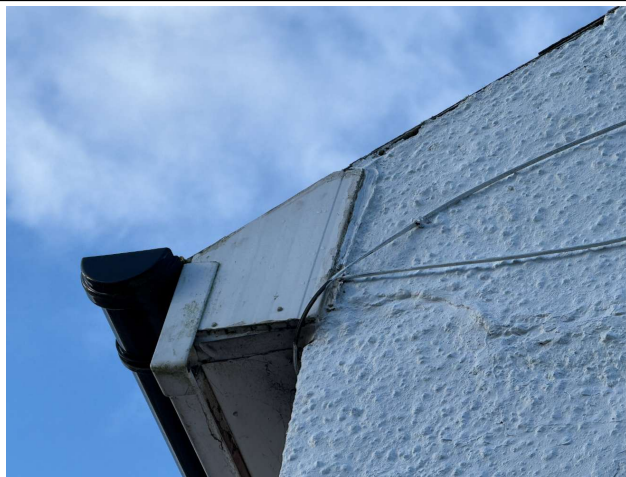
- This is poorly finished in places, for example, next to the rear gable. This could allow water to track behind causing hidden damage.

Poor fitting at rear.

You should ask an appropriately qualified person to assess the adequacy of the installation undertake any necessary remedial works soon. Where possible, the hidden areas should be checked for damage.

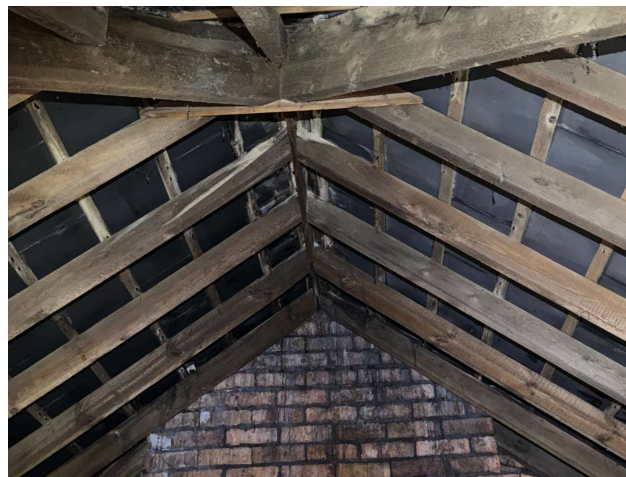
Note staining.

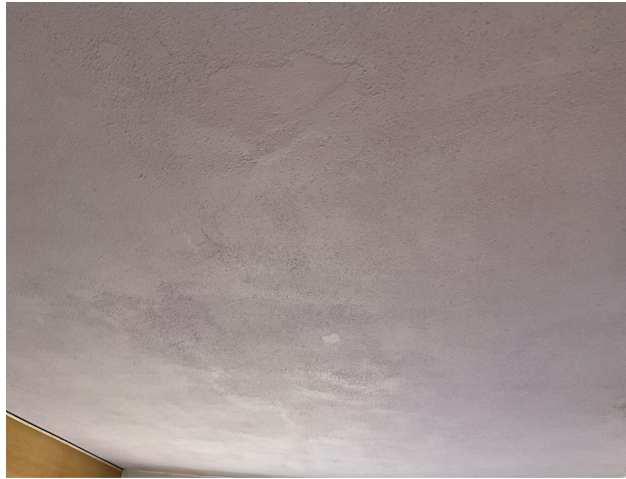
- The ceilings are cracked and uneven in places.

Note cracking and textured finish.

Lath and plaster ceilings are difficult to repair as large areas can be dislodged by the repair work itself. In some cases, it may be economical to replace the whole ceiling, and this can be more costly than repairs to modern ceilings. You should repair these soon.

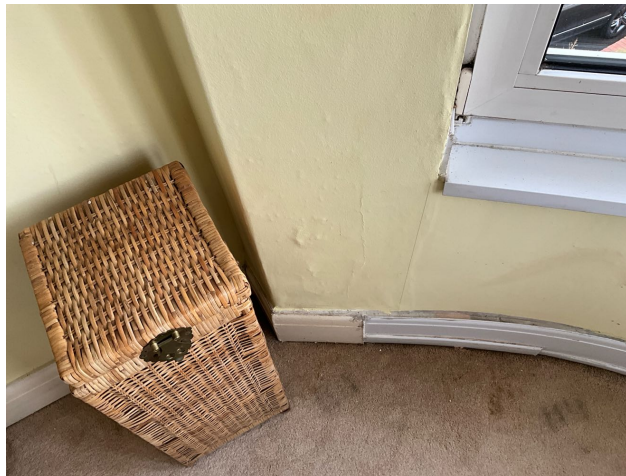
- There are areas of cracked and hollow plastic, including to the inner faces of the outside walls.

Defective plaster.

This is not considered to be structurally significant and much of this can be addressed upon redecoration. However, some repair and replastering work will be needed, especially if the wall paper is removed.

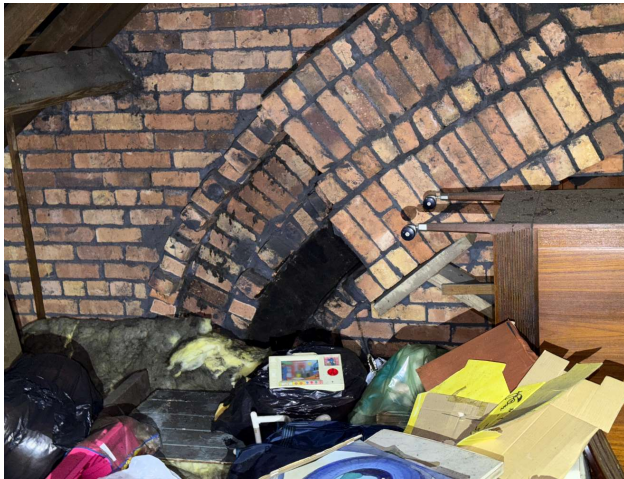
- The chimney breast in the front left bedroom has been removed, and the remaining chimney masonry in the roof space is not supported. This is a hazard. (See Section I – Risks).

Unsupported masonry.

Although this work may have been carried out some time ago, the chimney masonry and the roof space should be adequately supported. This should be assessed by an appropriately qualified professional and remedial works carried out as necessary now. Building regulation approval should be obtained.

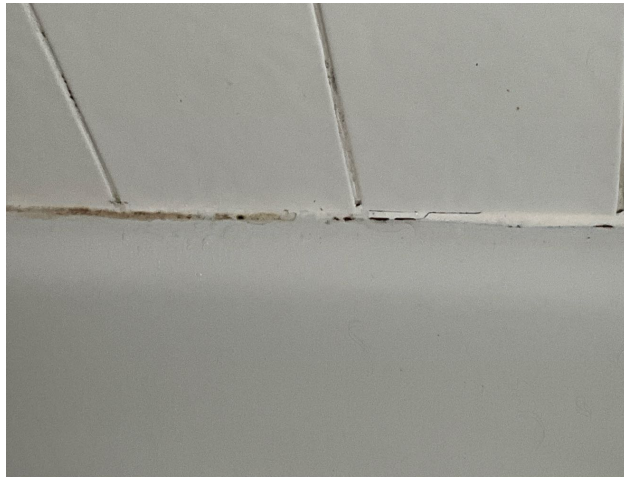
- The seal around the bath has split and is deteriorating.

Seal around bath.

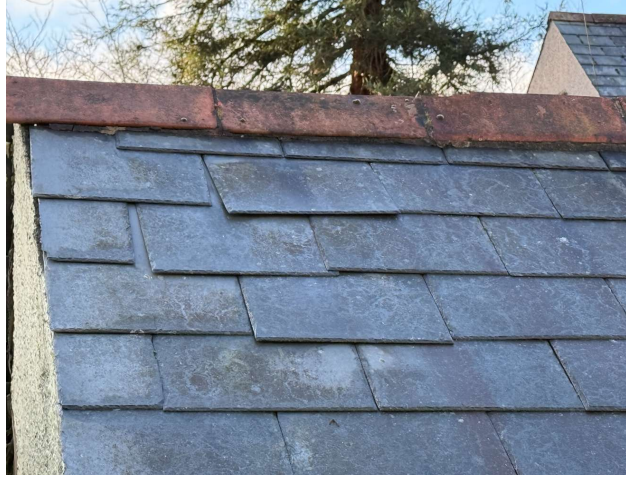
Loose tiles.

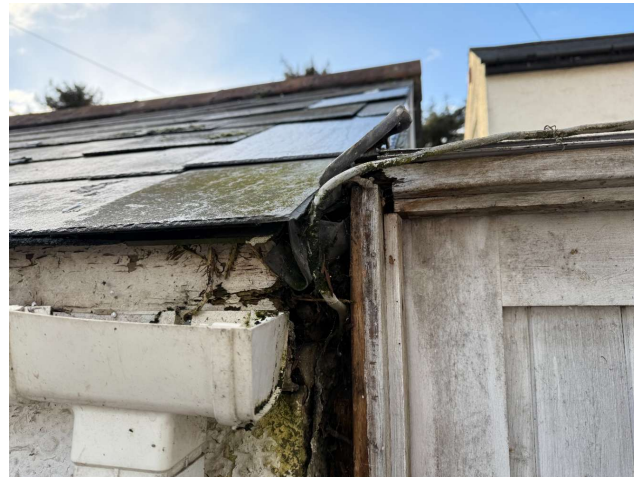
Rot.

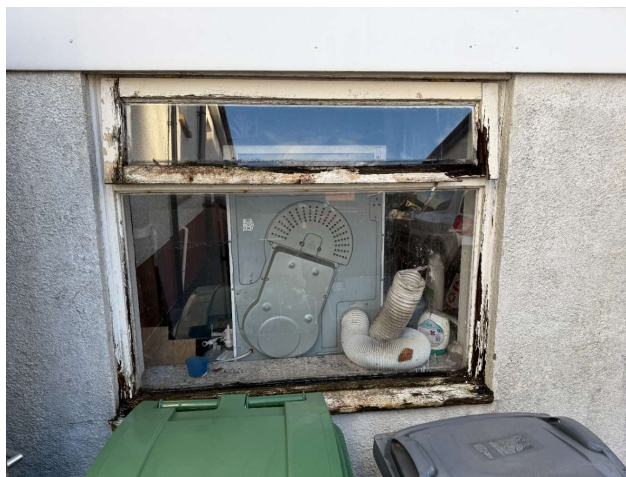
No safety glass, rot.

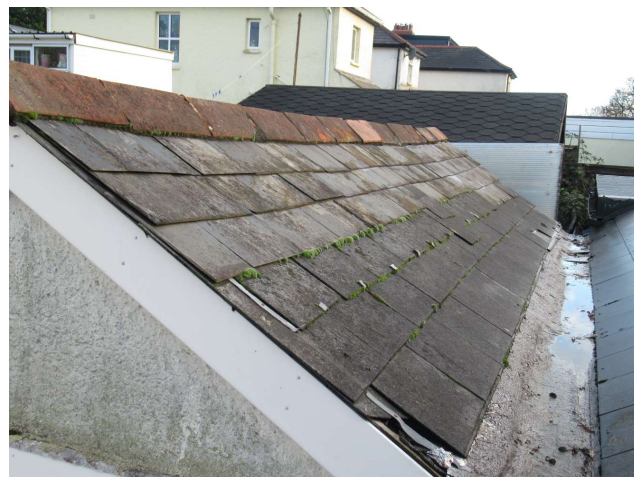
Also note gap where tile missing.

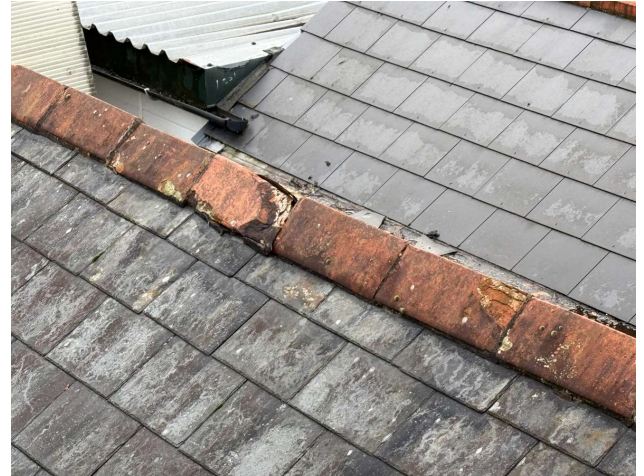
Loose material.

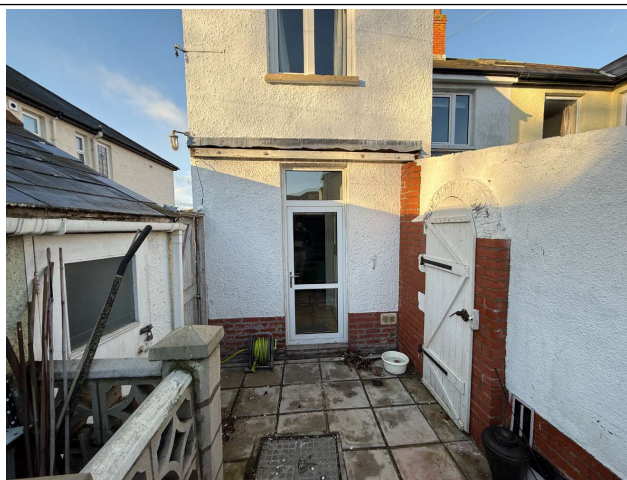
Remains of lean-to.

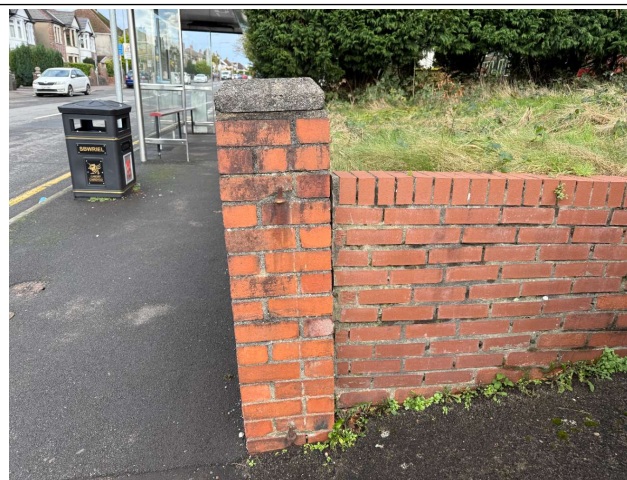
Leaning wall.
