LEVEL 2

Your survey report

6 Allensbank Road, Cardiff, CF14 3RB

06-01-2025

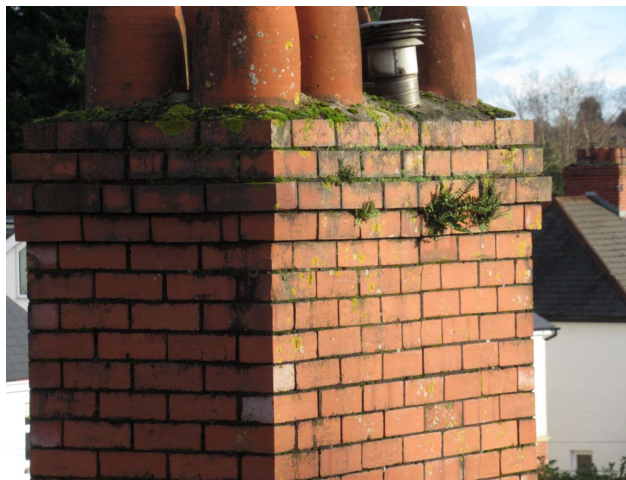
Loose material, uneven brickwork.

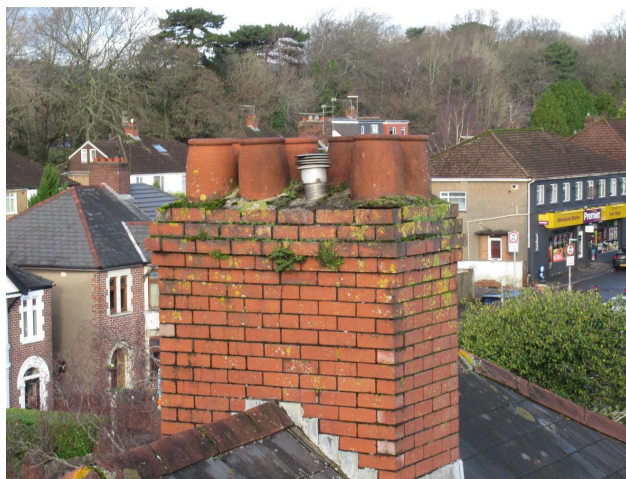
Side/rear.

- Terminal fittings should be fitted to the redundant pots which will allow ventilation but prevent rainwater penetration.
- The cement bedding holding in place the pots (called flaunching) is cracked and damaged.
- The mortar between the bricks (called pointing) is cracked, worn and missing.
- Part of the brickwork has displaced/is uneven. There is also some hairline cracking to the surface of the bricks which will deteriorate over time.
- Vegetation growth should be removed on any damage found made good. Old vegetation has also caused damage to the brickwork.
- Part of the lead flashing has dropped out of place. Some repairs have been carried out with silicon which will have a limited lifespan. There is general wear to the flashing.

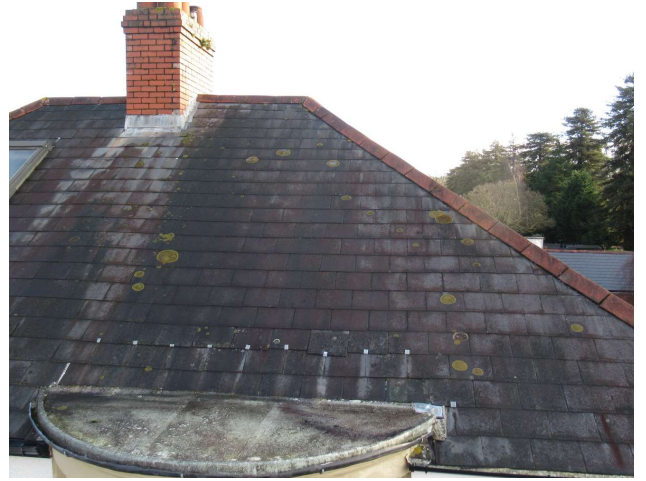
Front.

- These roof coverings are original to the house, and there is damage, wear and deterioration.
- Some slates have slipped and are missing. Several are held in place with metal clips called tingles.
- Some slates have been replaced with imitation slate tiles; these are deteriorating.
- The cement mortar holding in place the topmost ridge and hip tiles is worn and missing.
- There is some water penetration around the valley gutter area.
- The joint between the main roof and bay is poorly finished

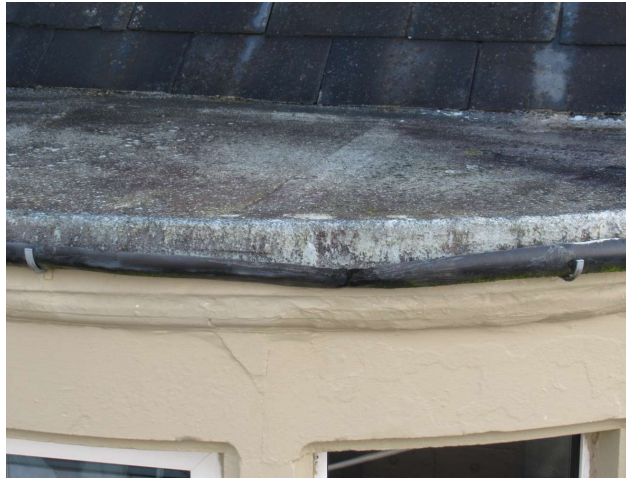
Bay.

The old metal fitting (noted at the front) is rusting and deteriorating and you should plan to replace it.

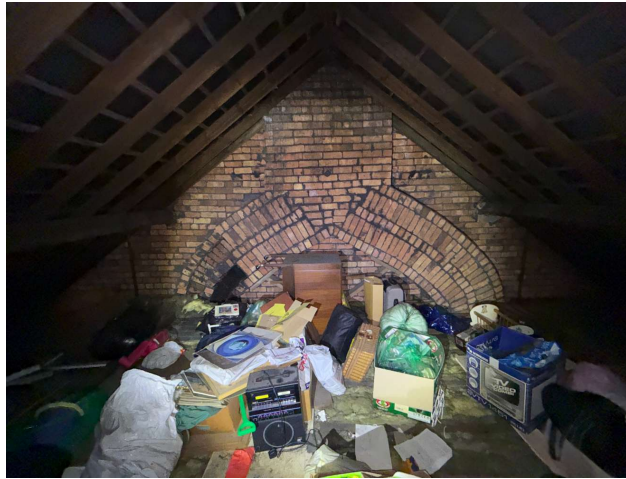
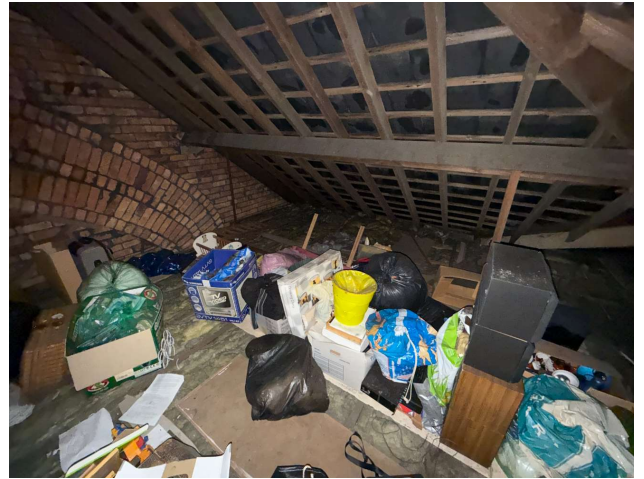
There is also some splitting of the main timbers, which is not uncommon, and there was no evidence of distress or failure. There is also some staining on the underside of the roof, possibly caused by driving rain. When the roof coverings are replaced, the timbers should be checked and it is normal to expect some remedial works.

Part of the chimney breast has been removed and I would refer you to my comments in section E5. Although part of the roof space is boarded, this area is intended to provide access for maintenance purposes and is not suitable for the storage of heavy items.

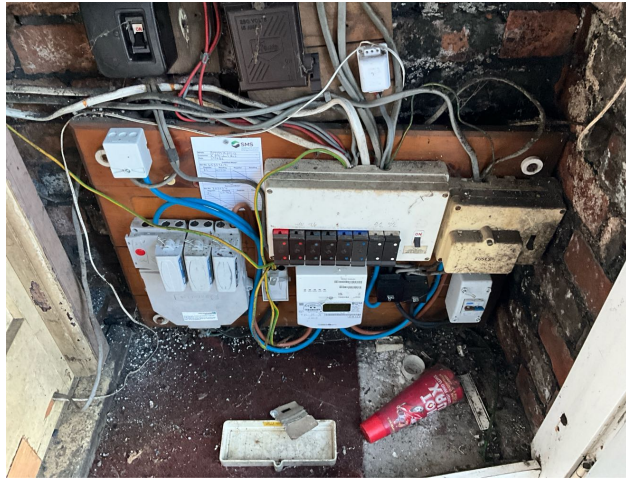
CONDITION RATING THREE.

This is a hazard. You should ask an appropriately qualified person to carry out a full electrical safety test now and advise you on a suitable course of action. This should also include the external wiring. You should budget for upgrading and replacing the electrical system, which will be costly and disruptive. (See Section I – Risks).

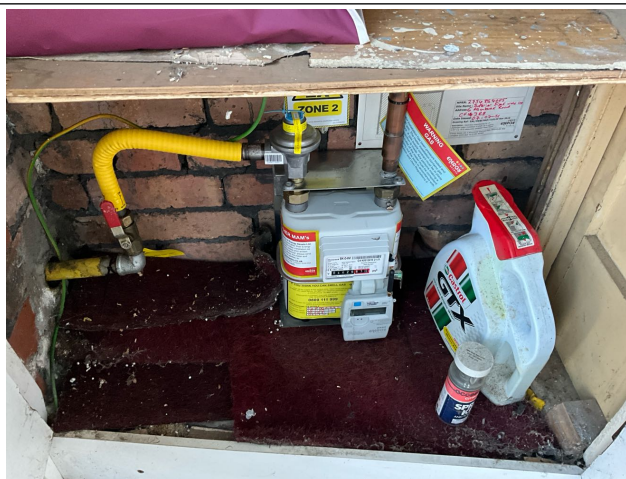
CONDITION RATING THREE.

You should ask an appropriately qualified person to carry out a gas safety test now.

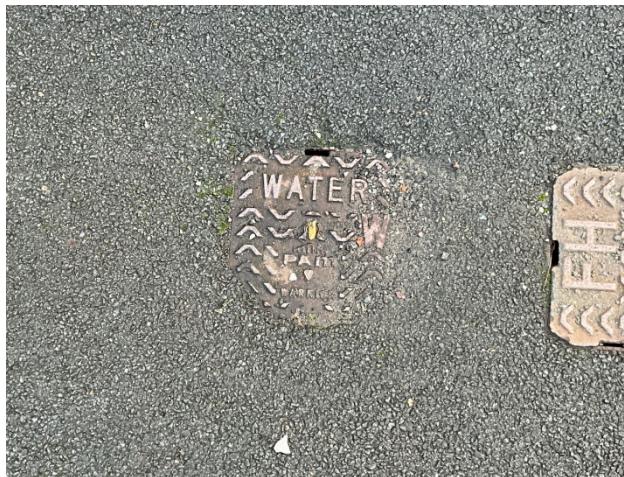
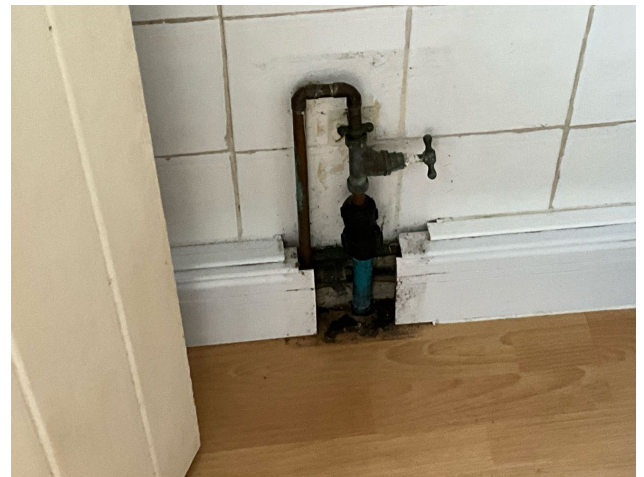
I understand that lead pipes form part of the internal plumbing. Not only does this increase the risk of lead getting into the water, but it is also a maintenance problem. Lead pipes can distort over time that can result in damaging water leaks. You should ask an appropriately qualified person to assess the extent of the lead pipework, replace the internal lead piping now.

You can contact Welsh Water for further advice. (See Section I-Risks).

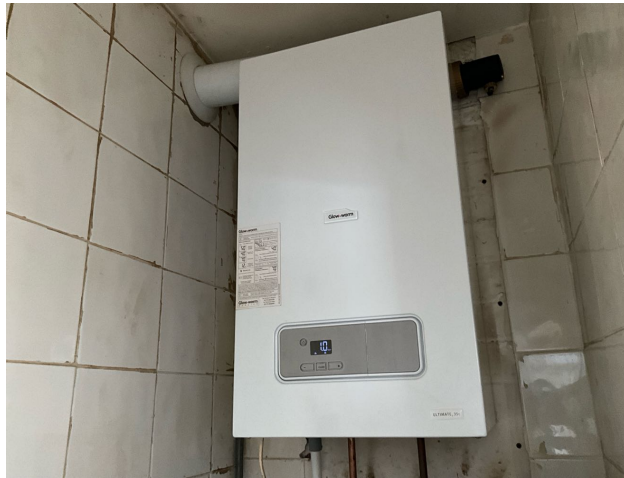
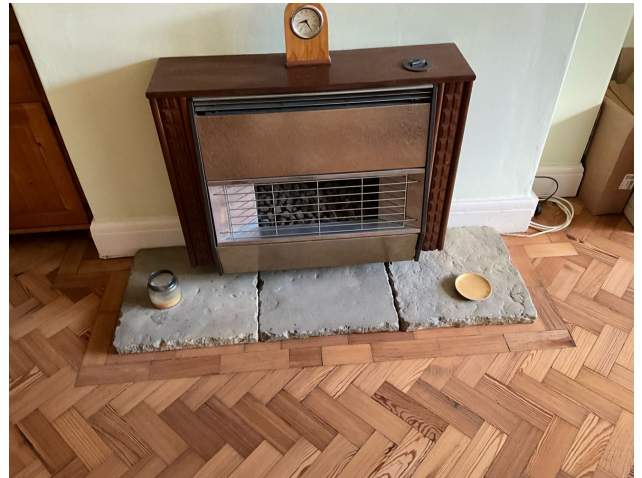
CONDITION RATING THREE.

This is a potential hazard. The gas fire should be checked, serviced or disconnected as necessary. If the boiler has not been serviced, this should also be carried out before occupation. (See Section I – Risks).

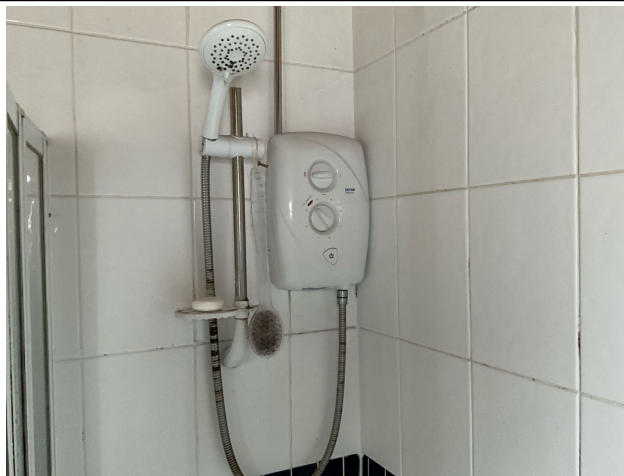
Hot water is provided by the main heating boiler without a storage tank. The hot water supply should be checked periodically, normally when the central heating boiler is serviced. If not, this can be a hazard. See Section F4.

Additional hot water is provided by an electric shower, you should ensure that this is included in the electrical safety test.

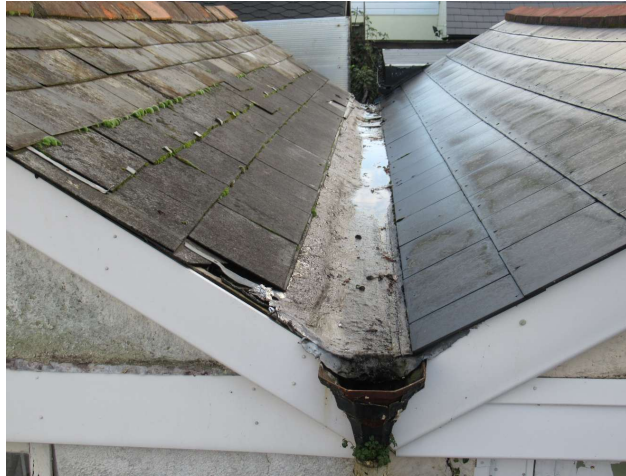
Valley.

Also note gap where tile missing.

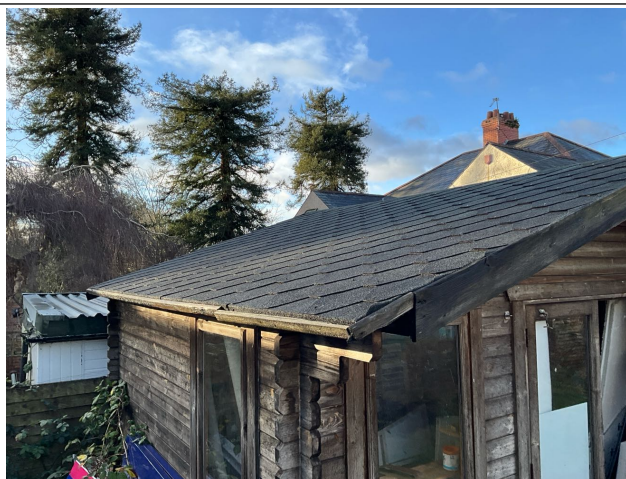
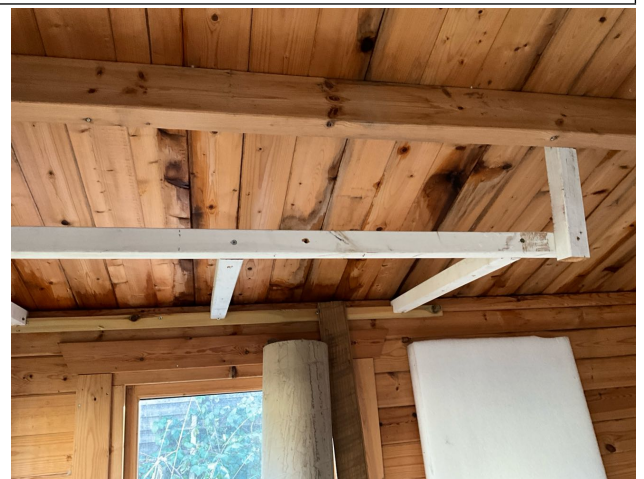
It is possible that issues such as rot become evident and you should budget for additional remedial works. The installation of guttering and rainwater goods is recommended to divert water away from the building and into the underground drains.

The roof should be repaired soon. As with the garage, this should be cleared internally and externally so an appropriately qualified person can carry out a proper assessment and advise you on a suitable course of action.
